## Appendix H.3: 3D Noise Contours for Ornithological Assessment

NorthConnect KS
Serviceboks 603, Lundsiden
N-4606 Kristiansand
Norway

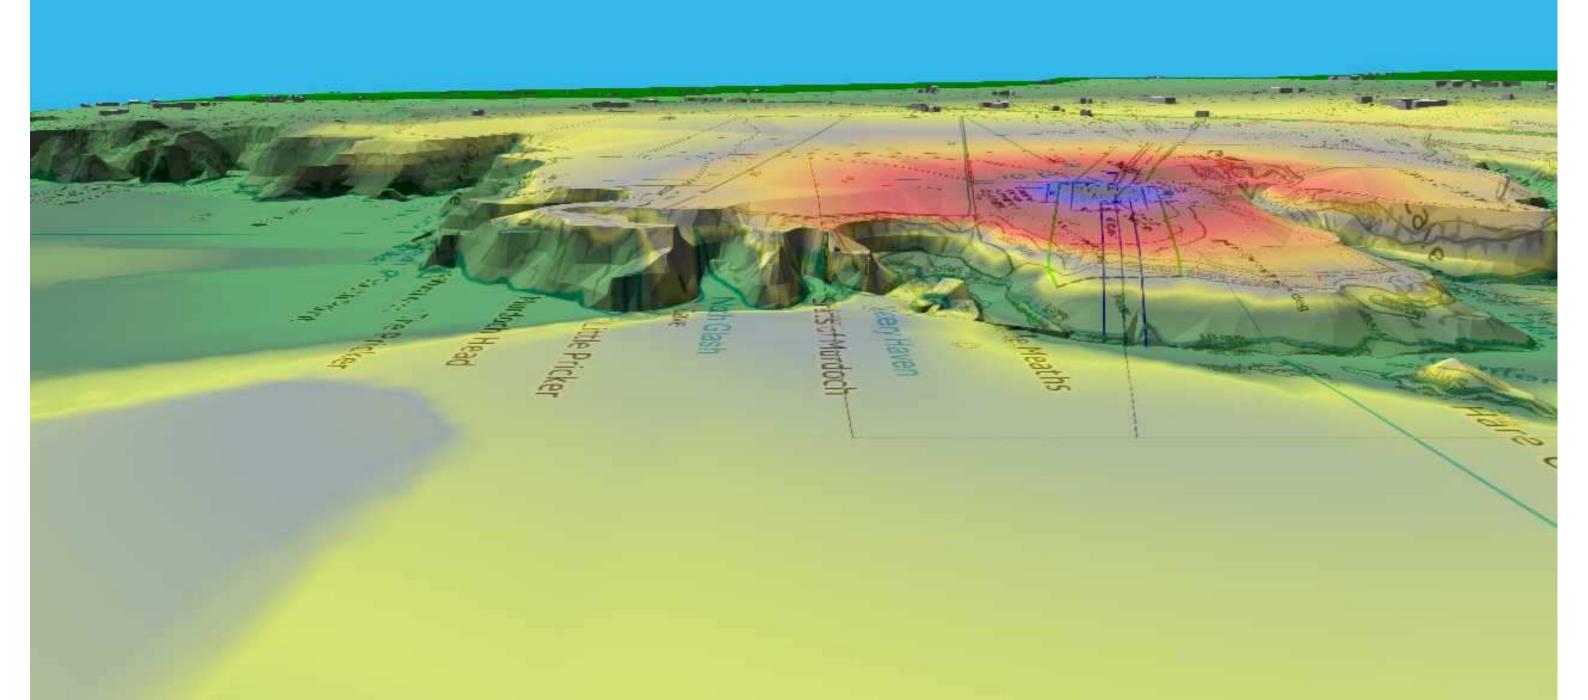
HDD onshore activities noise assessment: 3D image of noise modeling from Long Haven Bay: Photo 1

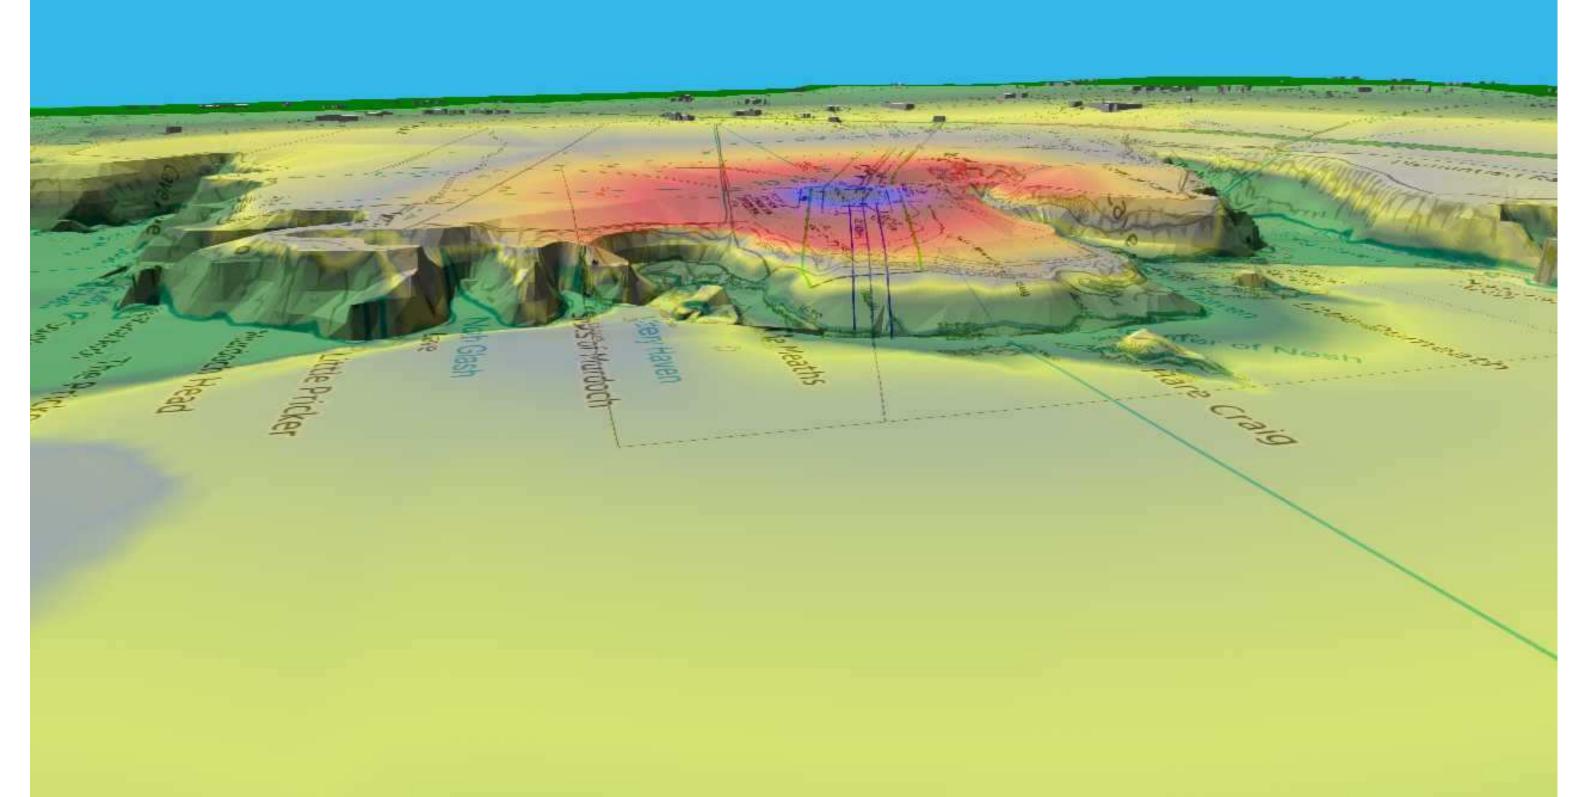
HDD onshore activities noise assessment: 3D image of noise modeling from Long Haven Bay:Photo 2

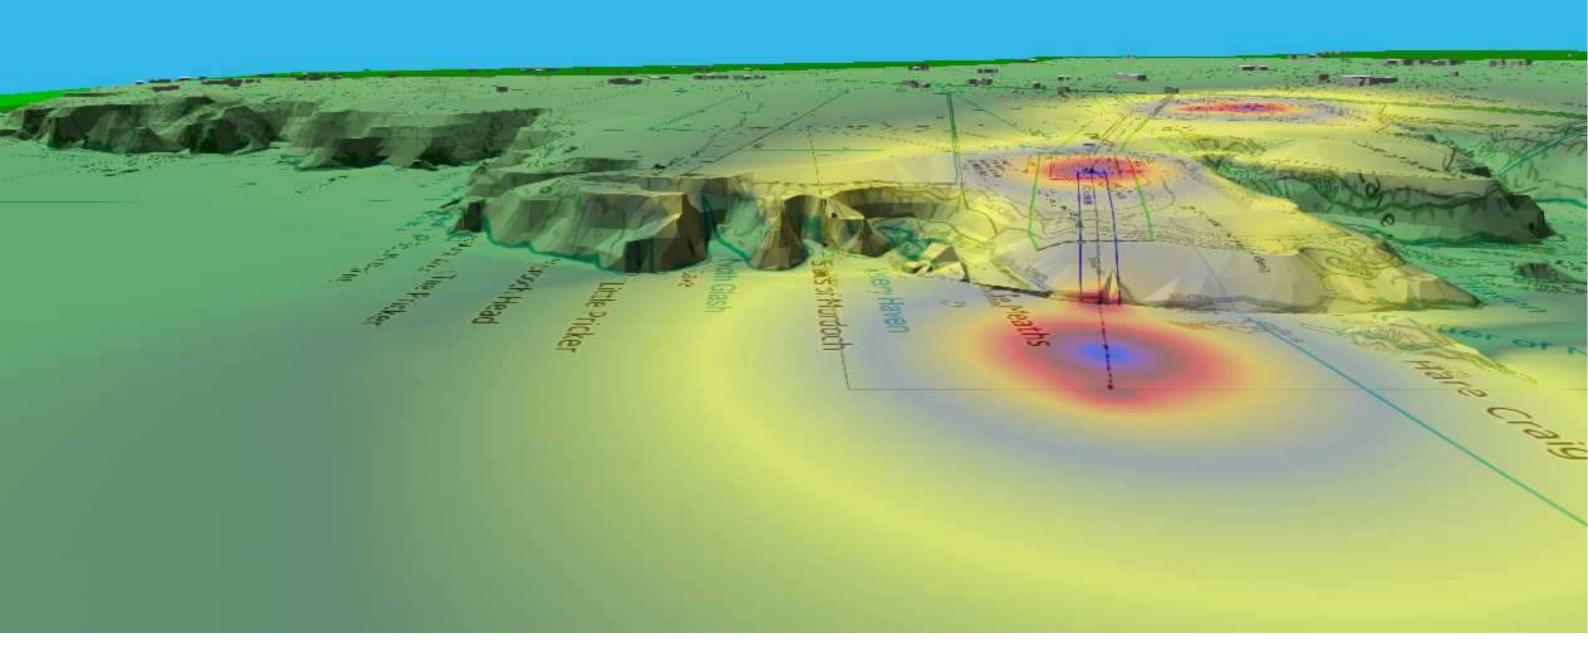
Cable pull activity noise assessment: 3D image of noise modeling from Long Haven Bay: Photo 4

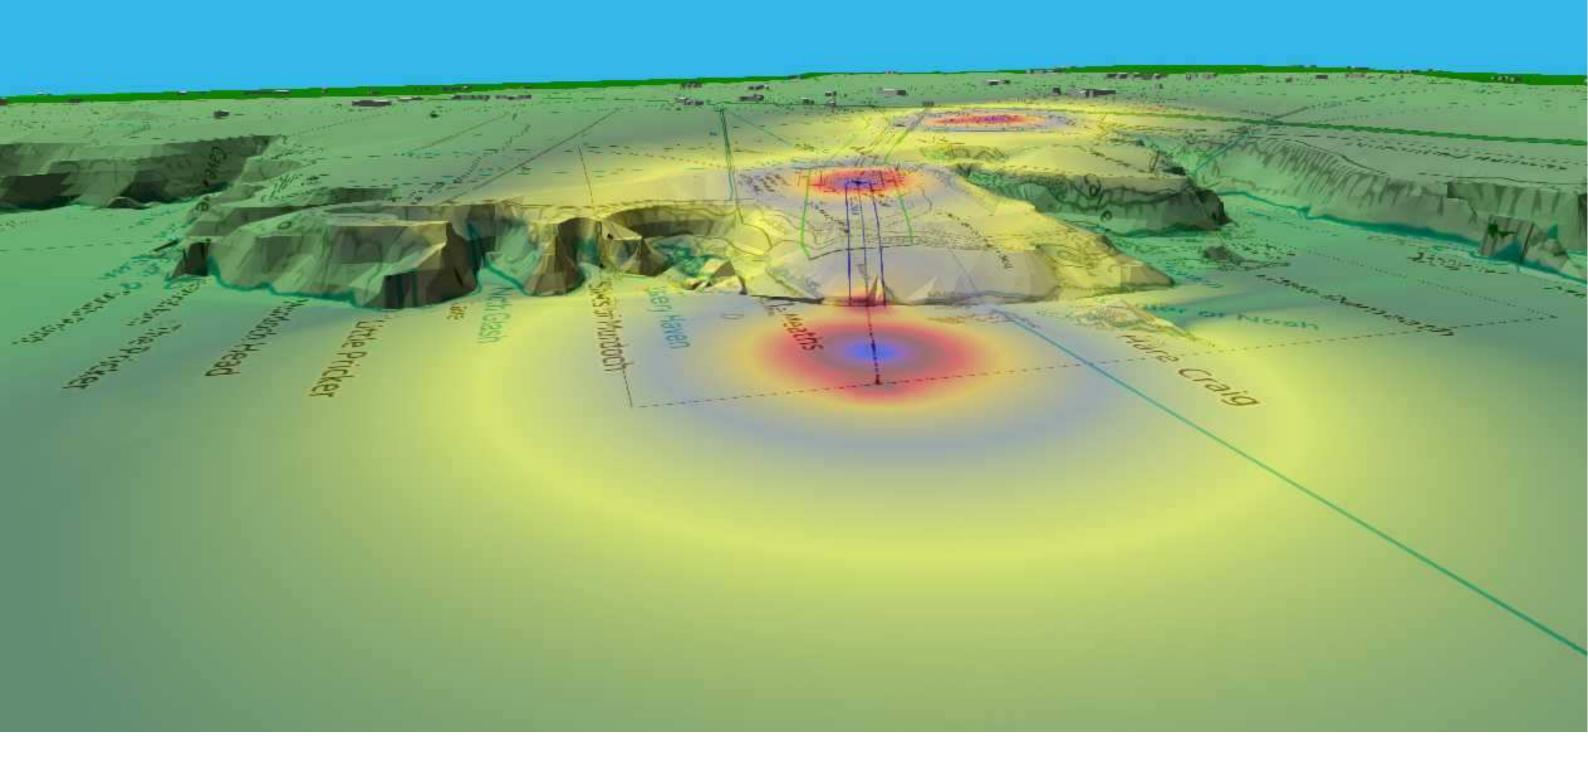
Cable pull activity noise assessment: 3D image of noise modeling from Long Haven Bay: Photo 5

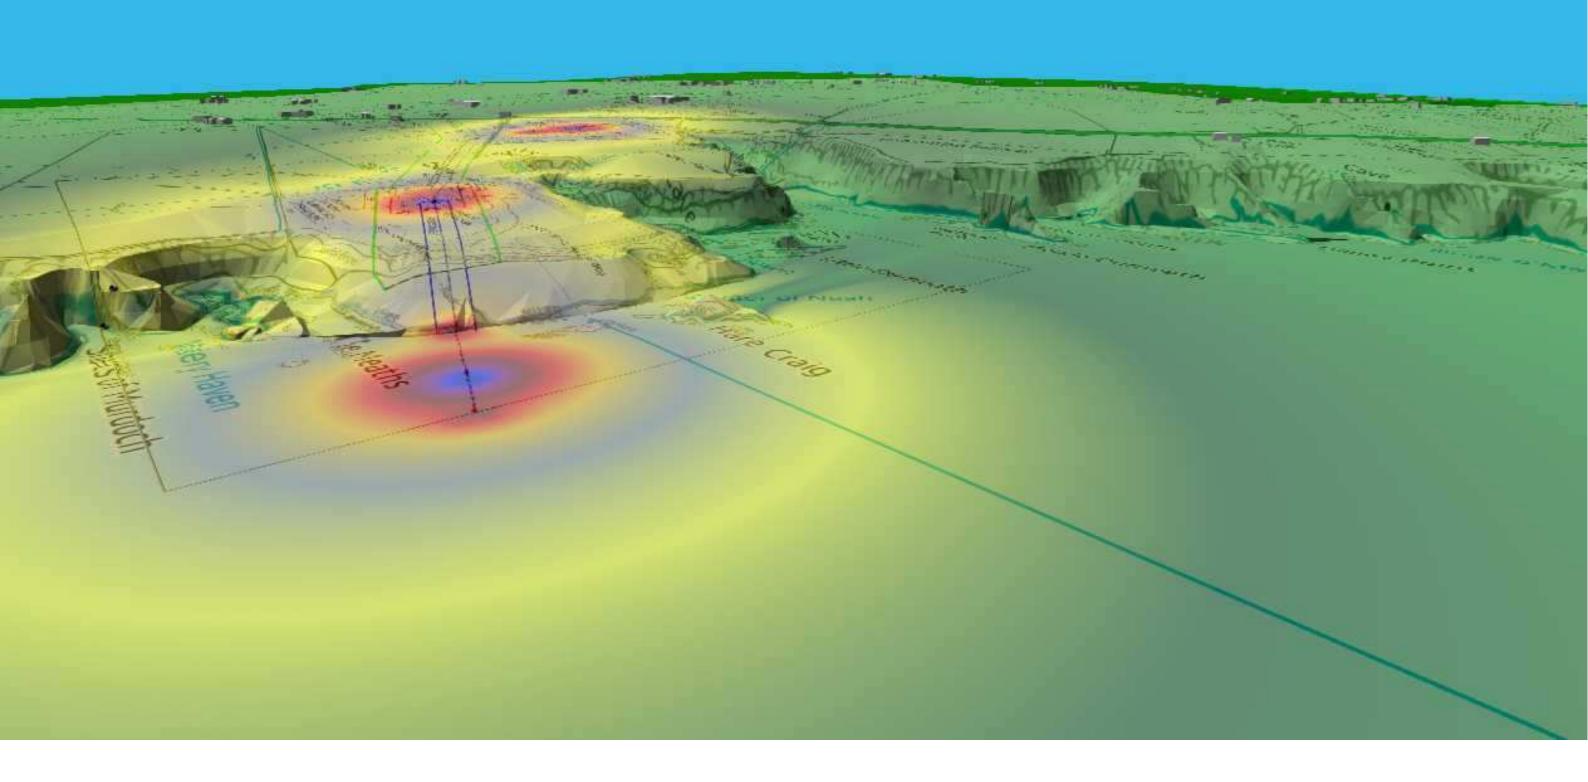
Cable pull activity noise assessment: 3D image of noise modeling from Long Haven Bay: Photo 6
